Characteristic structures of the Si(111)-7×7 surface step studied by scanning tunneling microscopy

Contrary to previous results concluding that all 7×7 boundaries in the down step edge were complete, 5×5 faulted half units were found to be introduced in part when the transition region was narrow. In addition, the formation characteristic of the 5×5 faulted half units was strongly influenced by the type of step configuration (nF or nU) and by the structure of the upper step edge (complete or incomplete). Even when the step configuration was the same, the difference in the upper step edge structures strongly affected introduction of 5×5 units. © 2001 American Vacuum Society. [DOI: 10.1116/1.1359538]

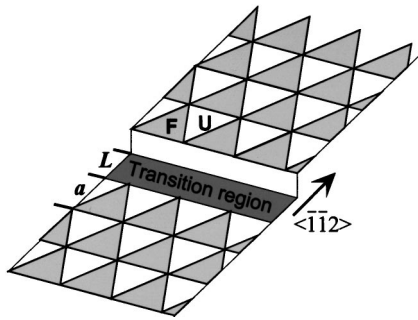
FIG. 1. Illustration of a step structure. *F* and *U* represent the faulted and unfaulted half units of a 7×7 structure, *a*: Length of the 7×7 half unit triangle; *L*: width of the transition region.

integer between 0 and 6 and a is the length of the 7×7 half unit triangle (Fig. 1). According to the value of n , steps are called nF or nU steps. For a value of n from 1 to 6, a region the size of which is shorter than the length of the 7×7 half unit, a , is introduced. The area is called the transition region.

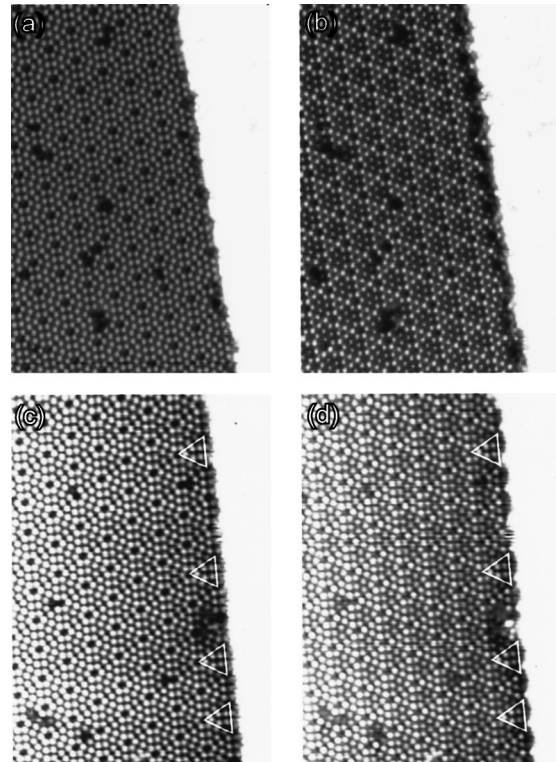
FIG. 2. STM images of (a), (b) $1F$ and (c), (d) $2U$ steps. The sample bias voltages are $+0.5 \text{ V}$ for (a) and (c) and -0.5 V for (b) and (d). Setting tunneling current is 0.3 nA . The triangles in (c) and (d) indicate the characteristic structure. The upper step is out of contrast.

Figure 2 shows STM images of $1F$ and $2U$ step edges of a Si(111)- 7×7 DAS structure. The sample bias voltages are $+0.5 \text{ V}$ (empty state) for Figs. 2(a) and 2(c) and -0.5 V (filled state) for Figs. 2(b) and 2(d). The steps observed are straight, and the upper terraces of the steps are terminated by the almost complete boundaries of the 7×7 unit cells at the step edge (complete step edge).

Next, let us focus on the structure of the down steps. In the case of the $1F$ step, 7×7 unfaulted half units form the straight boundary shown in Figs. 2(a) and 2(b). There is a transition region between the 7×7 boundary and the step edge. We cannot find peculiar results differing from the structures observed in previous work.

On the other hand, a peculiar structure, which has a characteristic adatom arrangement differing from the normal 7×7 adatom arrangement, was found in the case of the $2U$ step, and it is shown by triangles in Figs. 2(c) and 2(d). Figures 3(a) and 3(b) show a magnified STM image of the observed characteristic structure of the empty state and the filled-state, respectively. The *N* and *C* in Fig. 3 represent the

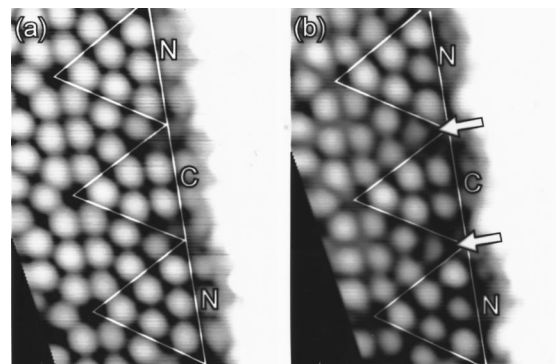
FIG. 3. Magnified STM images of the characteristic structure in Fig. 2. The sample bias voltage and setting current are (a) $+0.5 \text{ V}$ and 0.3 nA and (b) -0.5 V and 0.3 nA . *N* and *C* represent the normal and the characteristic half units, respectively. The arrows indicate the adatoms that were observed to be darker than those in the normal 7×7 arrangement. The upper step is out of contrast.

normal and the characteristic half units, respectively. The arrows in the filled state STM image [Fig. 3(b)] indicate that the adatoms observed were darker than those in the normal 7×7 arrangement. The brightness of the adatoms in the 7×7 DAS structure in the filled-state STM image reflects their second and third layer structures, i.e., the number of rest atoms around the adatoms.^{8,18,19} Therefore, the adatoms indicated by arrows in Fig. 3(b) are surrounded by more rest atoms than normal 7×7 adatoms. On the basis of this, we

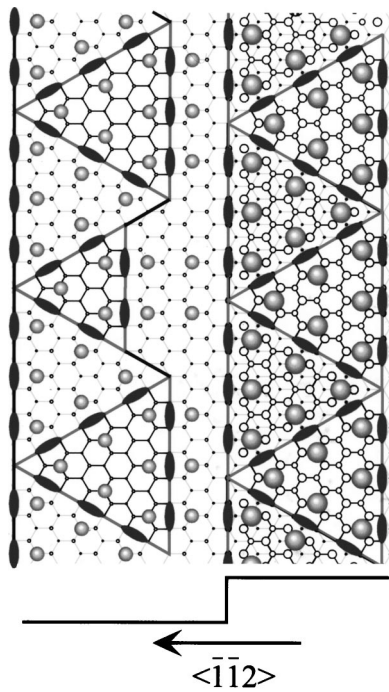
FIG. 4. Schematic model of the characteristic structure in Fig. 3.

can conclude that the characteristic structures observed consist of 5×5 faulted half units, as shown in Fig. 4 schematically. Therefore, the 5×5 structure is introduced in the step region as expected.

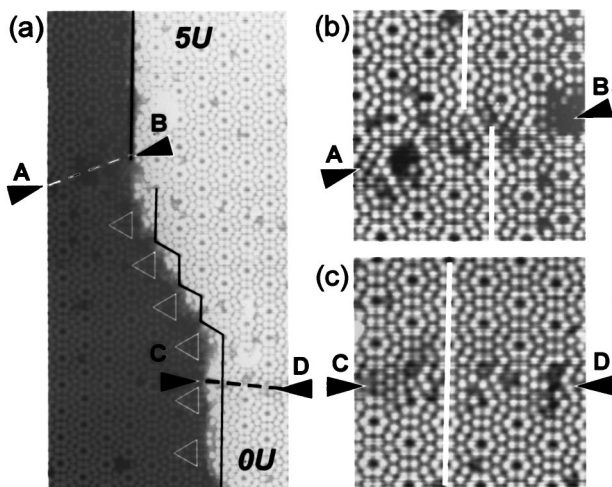
FIG. 5. (a) An empty state STM image of a step structure. Two phase boundaries are indicated by arrows in the image. White triangles show the 5×5 faulted half units introduced. The dashed lines indicate the phase boundaries. (b), (c) Magnified STM images of phase boundaries A–B and C–D in (a). In (b) and (c), the vertical lines through the phase boundaries show the phase shift between two 7×7 domains.

Next, we consider the correlation between the conformation of the upper step edge and the emergence of the characteristic structure. Figure 5(a) shows an empty state STM image of a step structure. Here, straight and zigzag structures coexist at the step edge. There are two phase boundaries, indicated by arrows in Fig. 5(a), and magnifications of them

are shown in Figs. 5(b) and 5(c). Phase mismatching at the boundary C–D is in the direction of $[\bar{1}10]$, which does not influence the step configuration between lower and upper steps. On the other hand, the phase boundary A–B has an influence on the step configuration because the phase mismatch is in both directions, $[\bar{1}10]$ and $[11\bar{2}]$. As a result, the step types changed across the phase boundary, namely, from $5U$ on the upper side to $0U$ on the lower side.

It is noted that 5×5 faulted half units are introduced only when the transition region is narrow, such as in the case of $0U$ – $2U$ steps. They were not observed in the wide transition region such as in the case of $3U$ – $6U$ steps as shown in Figs. 5 and 6. These facts indicate that the width of the transition regions primarily affects the introduction of 5×5 faulted half units. Then, the introduction of 5×5 faulted structures may reduce the strain energy further depending upon the structure of the upper step edge.

joined to each other, namely, there exists a certain space between the 5×5 structures, as clearly seen in Fig. 5. An optimum structure must exist.

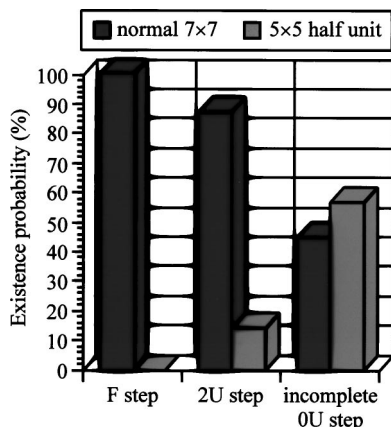
FIG. 7. Existence probability of 5×5 faulted half units at the lower step edge counted from the STM images.

Finally, the existence probability of 5×5 faulted half units is considered to be different from each other because the structure of an upper step edge is different. Figure 7 shows an example of the existence probability of 5×5 faulted half units at the lower F step edge. On the other hand, in the case of the U step, the existence probability at $2U$ and incomplete $0U$ steps are 0.13 and 0.56, respectively. These results clearly indicate as expected that the introduction of 5×5 faulted half units is affected by not only the width of the transition region but also by the structure of the upper step edge.
